TECHNICAL REPORT CERC-88-16

SIDE-SCAN SONAR APPLICATIONS FOR EVALUATING COASTAL STRUCTURES

James E. Clausner, Joan Pope

Coastal Engineering Research Center

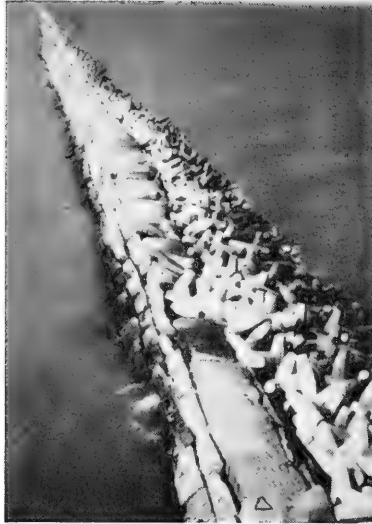
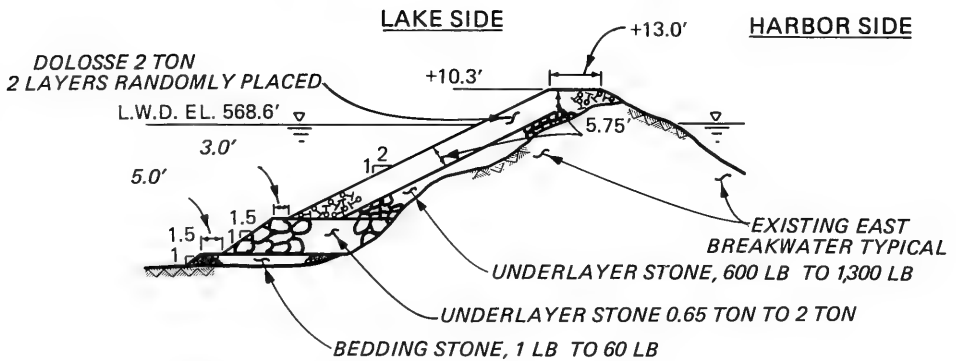
20. The eastern 4,400 ft of the Cleveland Harbor breakwater (Figure 7) was rehabilitated with over 29,000 2-ton unreinforced dolosse in 1980 and 1981 (Figure 8). Funding from the MCCP Program provided for a series of monitoring efforts to assess the condition of this structure. An integral part of the monitoring program was the use of side-scan sonar to evaluate the underwater condition of the dolos rehabilitated section. The monitoring effort gained additional significance after an April 1982 storm (with a 100-yr return period

Figure 8. Dolosse rehabilitated section of Cleveland harbor breakwater

water level) damaged the structure. Effects of the high water level on the structure were amplified by large waves which included ice chunks and debris.

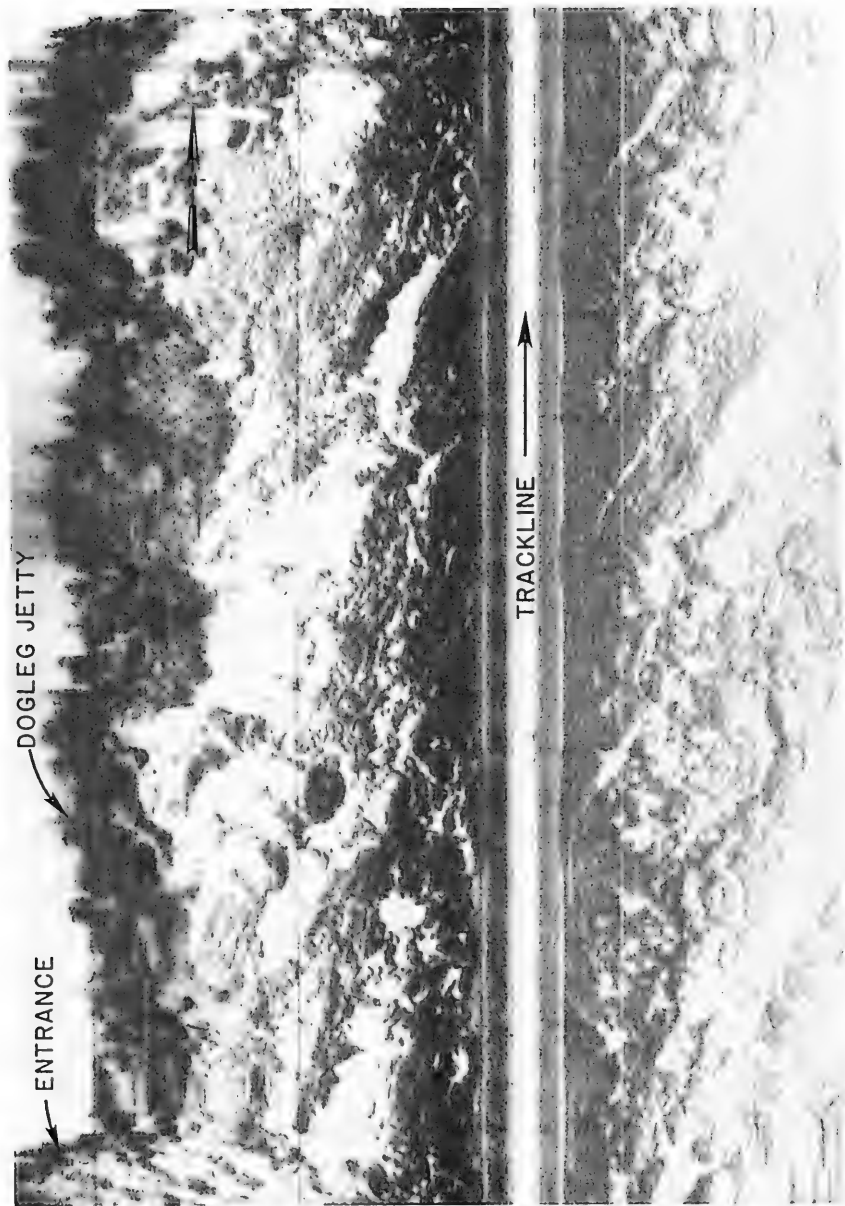
- a. Seaward of the entrance channel and dogleg portion of the north jetty, the bottom is devoid of sand, suggesting that little transport takes place just outside the structure. The sonograph indicates that a 200-ft width of the bottom seaward of the toe of the dogleg is a clean surface of rough coquina limestone (Figure 29).

Figure 29. Ocean side of the north jetty outer section at St. Lucie Inlet, Florida; 50-m range, 500 kHz

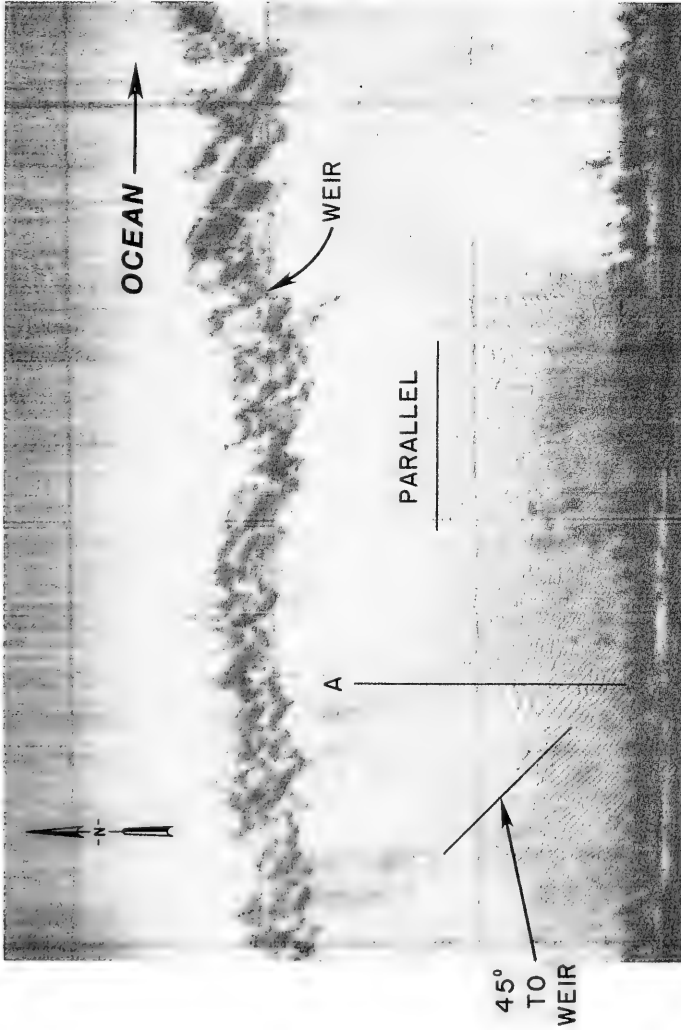
- c. The ripple patterns inside the weir have important implications for the design of the deposition basin. Ripples at the seaward and middle portions of the weir are roughly parallel to the weir (Figure 30). A dramatic change in the angle the ripples make with the weir occurs along a line approximately 200 to 250 ft from the landward end of the weir. At line A, the angle changes to approximately 45 deg. This phenomenon indicates that the primary wave and current flow direction changes about 1/3 of the way along the length of the weir to focus the inshore sediment transport toward the southeast corner of the spit. The region west of line A then becomes a potential location for the intake of the sand bypassing plant.

Figure 30. Inlet side of the weir section of the north jetty at St. Lucie Inlet; 50-m range, 500 kHz

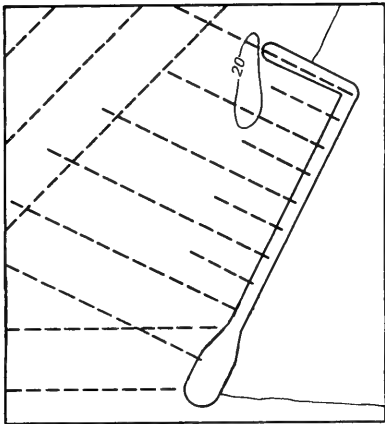
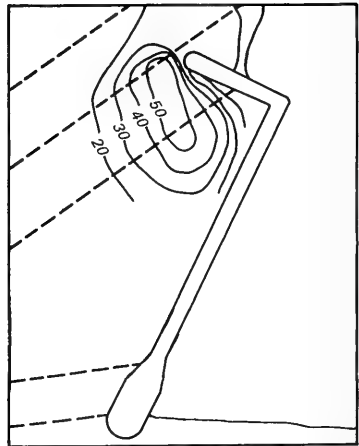
58. Standard bathymetric surveys around the jetties were also obtained at 200-ft intervals. Comparison of Figures 32a (showing the results of a survey taken in July 1985) and 32b (showing the results of a survey taken in August 1986) illustrates the difficulty of delineating small-scale features at typical bathymetric survey line spacings. Notably, the fathometer survey tracklines miss the center of the scour hole. The principal benefit of a side-scan sonar survey, in this instance, is to identify and locate areas that require closer spacings between bathymetric survey lines.

Figure 32. Scour hole development at southwest tip of east jetty at East Pass Inlet, Florida
